## REPLACEMENT OF WELDED TUB AND COUNTERWEIGHT

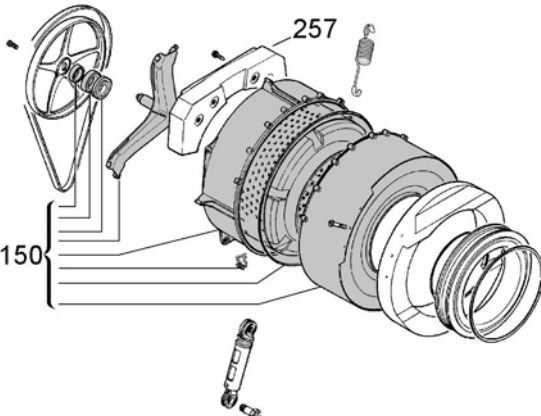
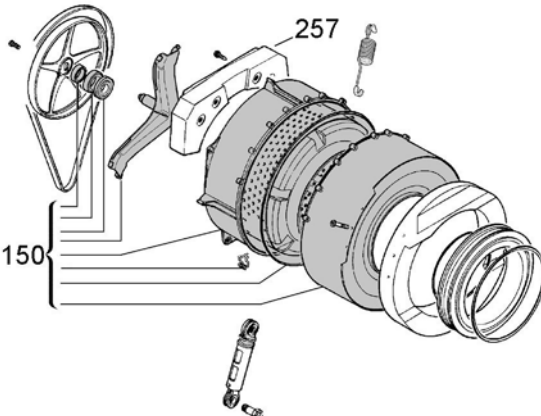
OLD			NEW

The welded tub part no. 126 85 72-30/0 is not available as spare part anymore.

As a replacement a welded tub part no. 126 85 75-00/6 is supplied.

**Simultaneously it is obligatory to replace also the rear counterweight.**

Pos.	Description	Part no.	Pos.	Description	Part no.
150	Welded tub assembly	<b>Depleted</b>	150	Welded tub assembly	<b>126 85 75-00/6</b>
257	Rear counterweight	<b>126 05 19-00/2</b>	257	Rear counterweight	<b>126 05 19-50/7</b>
