SERVICE BULLETIN
Factory of Alcalá Spain

REPLACEMENT OF WASHING GROUP

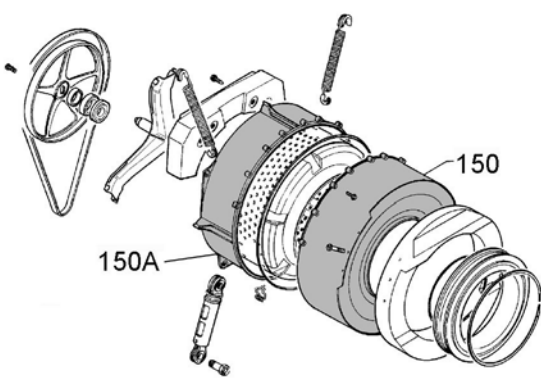
We inform you that the rear and front shell of the screwed washing groups are not available anymore as spare parts.
The welded shell assembly is delivered as a replacement and can be mounted in place of the screwed one.
