Date 12.09.03	Ref. No. AU02802R1	Model CDP-SP55, HCD-CP101, HCD-CP300, HCD-CP500MD, HCD-DX10, HCD-DX20, HCD-DX30, HCD-DX90, HCD-J300, HCD-M10, HCD-M70, HCD-RG20, HCD-RG22, HCD-RG33, HCD-RG55S, HCD-RG66, HCD-TB10, HCD-VP100, HCD-VX222, HCD-VX333	HA
Subject Different CD Playback Problems [REVISION 1]			IRIS 1551

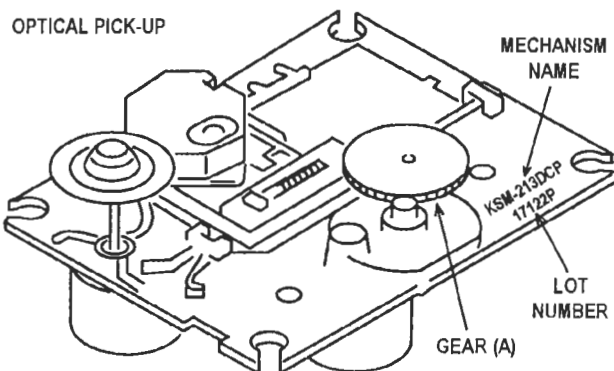
The diameter of the axis of the part "Gear (A)" is too small so that the rack of the optical pick-up does not engage with the gear.

As only a limited number of KSM mechanisms is equipped with the improper "Gear (A)", check the affected lot number range as outlined below.

- Confirm the name of the mechanism: **KSM-213DAP, KSM-213DCP, KSM-213DHAP**.
- Confirm that the lot number ranges between 28122P and 12522P. In this number the first two digits represent the day, the third represents the month and the fourth represents the year of production. In this particular case it concerns the mechanisms manufactured between 28 January 2002 and 12 May 2002.
- Erase the lot number with a marker after replacing the "Gear (A)".
- Apply a small drop of "FLOIL (KG-70MP)" (J-2501-171-A) to the bearing of "Gear (A)".
- Perform an ageing test after replacing "Gear (A)" and confirm the correct operation.

Replace the part "Gear (A)" (2-626-907-02) with the improved type **2-626-907-11**.
