SERVICE TECHNICAL news

STN - WM - 0405.1 - EN

Indesit Company, Service Department

Title: **CARD/EEPROM INCOMPATIBILITY ON ELECTRONIC WMs**

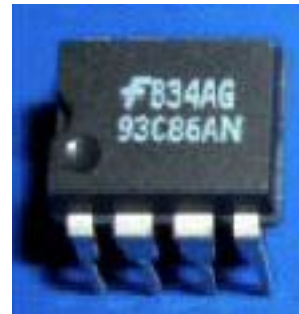
**Eeprom supplier:
Fairchild
(white writing)**

Incompatibility between the cards without the three blue capacitors (shown in the photos of the table on page 2) and the eeproms of the new "ST" supplier. In other words, the eeproms of the ST supplier require the three blue capacitors in order to operate correctly, whereas the eeproms of the previous Fairchild supplier did not.

As described in the "products concerned" section, the fault only occurs when the card or eeprom is replaced and not matched correctly (therefore check stocks in your warehouse, keeping in mind that the Fairchild supplier no longer exists).

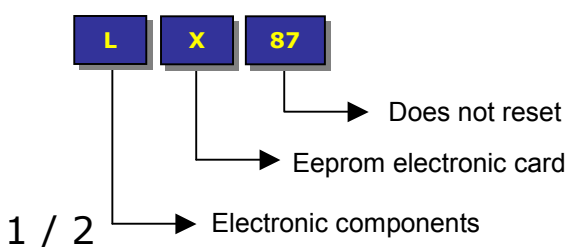
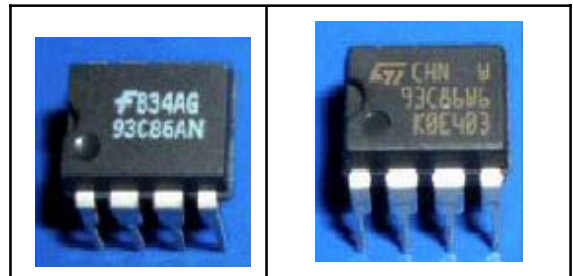
Incompatibility between cards and eeproms	Fairchild	ST
---	-----------	----

<p>Module with IDC wiring with capacitors</p>	<p>O.K.</p>	<p>O.K.</p>
	<p>Module with IDC wiring without capacitors</p>	<p>O.K.</p>	<p>Malfunctions Does not reset F03 F09</p>
	<p>Old module with capacitors</p>	<p>O.K.</p>	<p>Malfunctions Does not reset F03 F09</p>
	<p>Old module with capacitors</p>	<p>O.K.</p>	<p>O.K.</p>
