Service - Info

Unit type : Chassis DTV 101

KD0002K

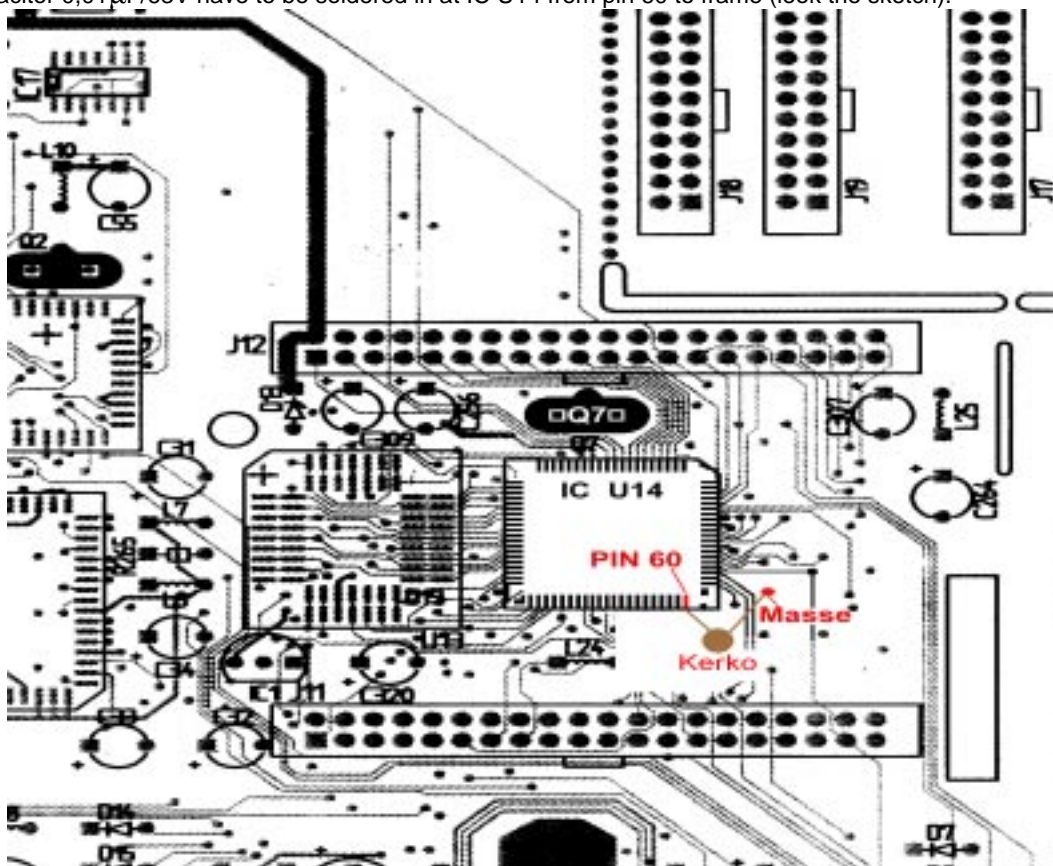
Disturbance at channel 4

- A capacitor 0,01 μ F/63V have to be soldered in at IC U14 from pin 60 to frame (look the sketch).

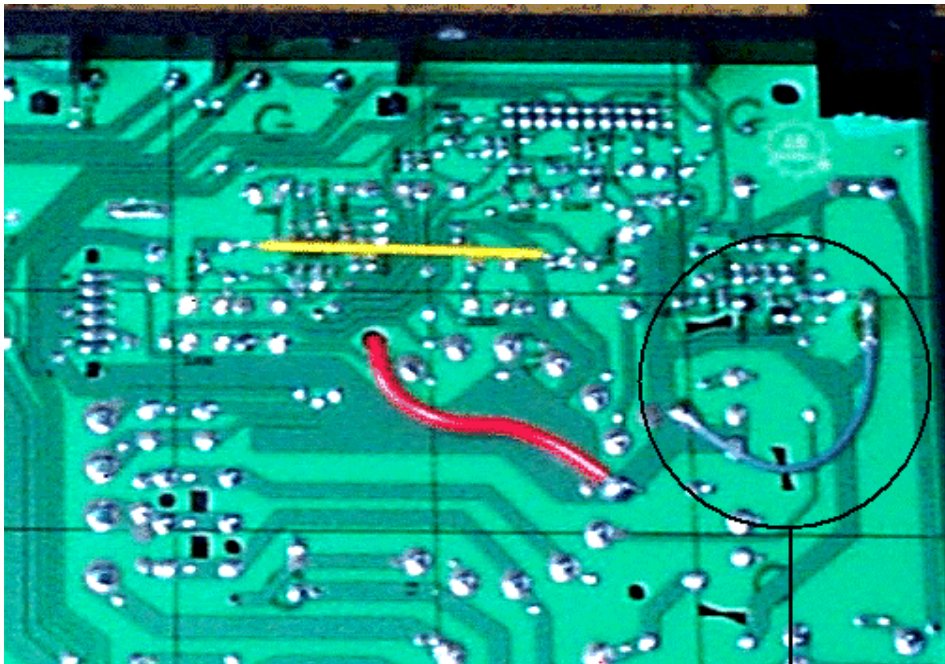
Frame connection

Vertical interference pattern

Extra frame connection cooling plate deflection (see illustration)

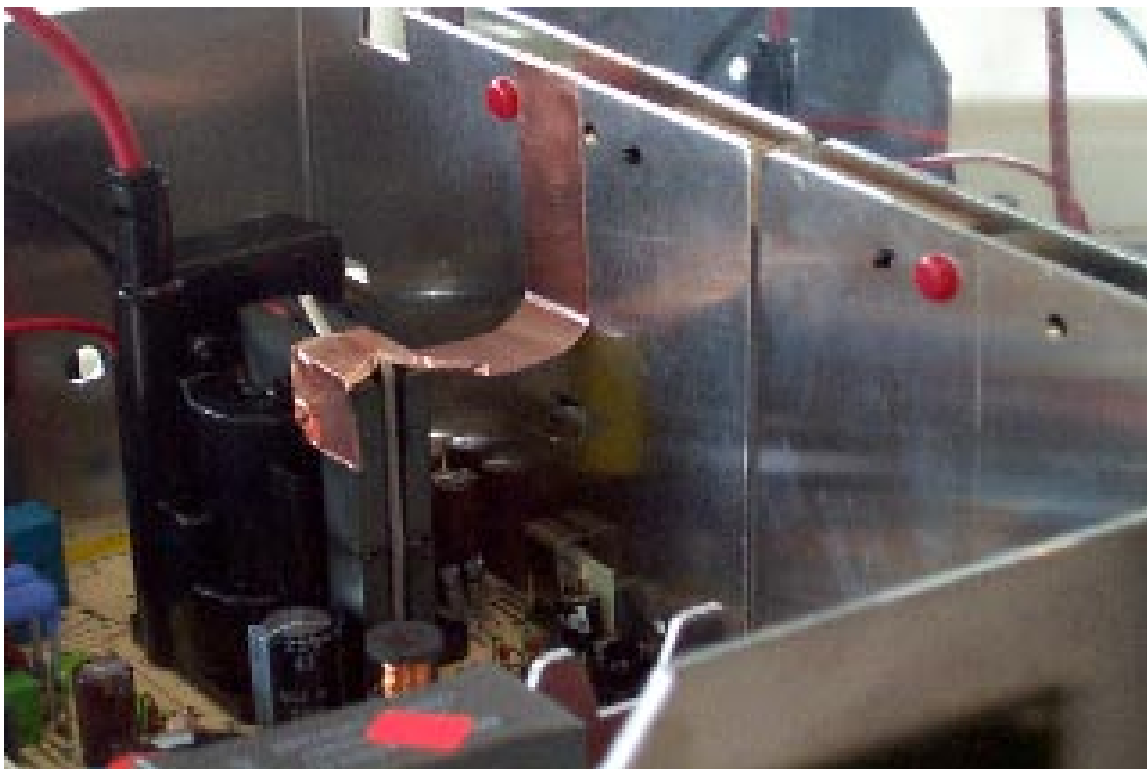
Breakdown of the vertical output amplifier (IC 401 / TDA 8177 F)

- After the breakdown of the vertical output amplifier (IC 401 / TDA 8177 F) the soldering connections in the area around the vertical amplifier and the east/west correction have to be observed or soldered again respectively.
- The capacitor 2,2 nF / 100V (part no.: 0061416) has to be componented additional between pin 3 of IC 401 and ground.
- The copper conductor between the diode split transformer - ferrit tube and the cooling shield has to be componented a like the following illustration.
