Service-Bulletin

Washing machines

Toploader

Program abort fault display EA0 / fault memory EA6 with program start

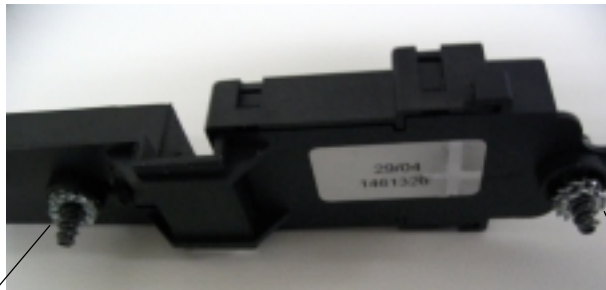
Onewasher

Two washers

Assemble DSP at the top with one washer, at the bottom with two washers.
