Date 13.05.05	Ref. No. <b>05PV032</b>	Model <b>DCR-DVD92E, DCR-DVD202E, DCR-DVD203E, DCR-DVD403E</b>	PV
Subject <b>No Power, No Key Operation, VC Board Handling</b>			IRIS 1111 117P

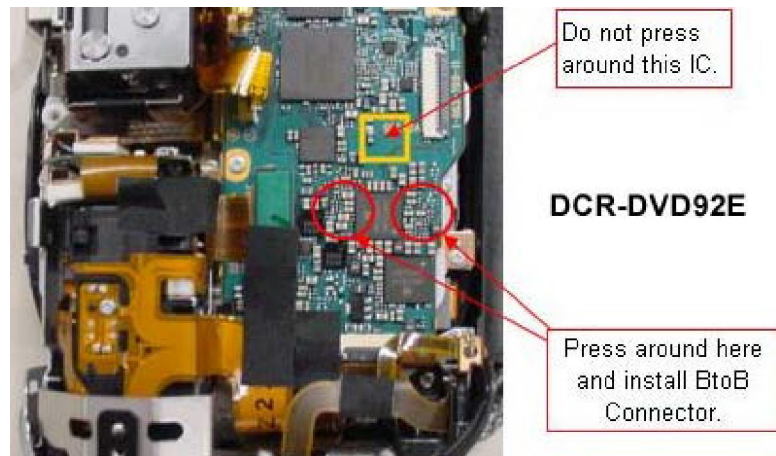
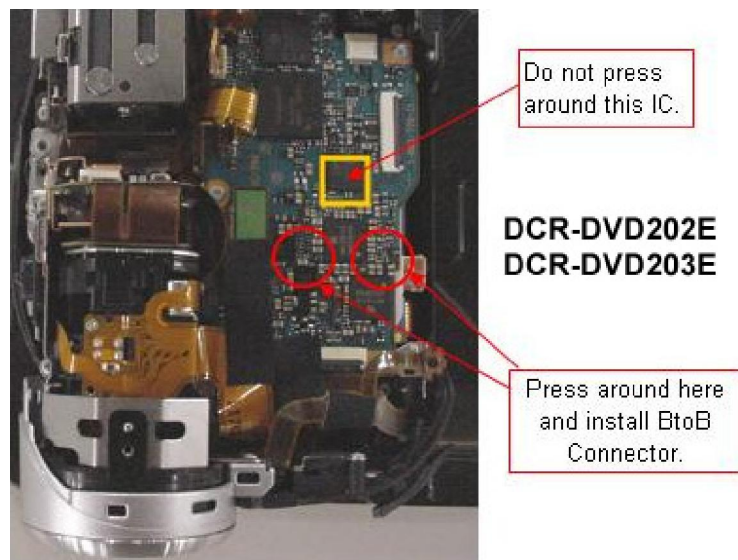
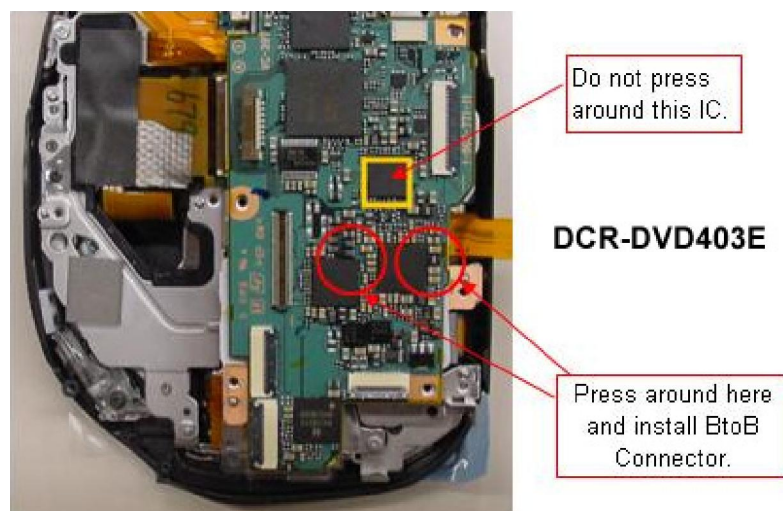
Cracks in the soldering of IC2301 resulting from installing the B-to-B connector CN1107 onto the VC Board.

- Reinstall the B-to-B connector **CN1107** onto the VC Board as indicated below for each model.
