Date	Ref. No.	Model	
07.09.05	05HA029	HCD-CP555, HCD-CPX22, HCD-NXM1, HCD-NXM3	HA
Subject			IRIS
No Mechanical Operation, No RDS Reception, No Power			1610 1285 1111

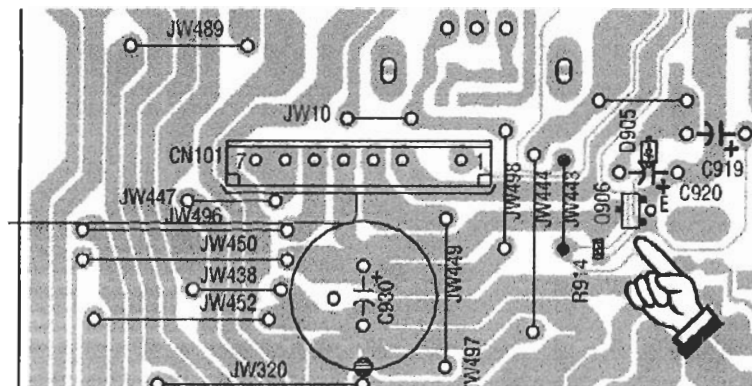
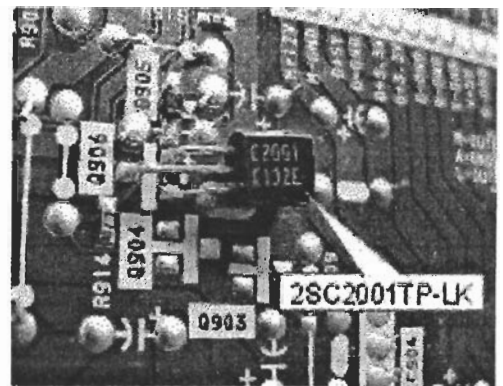
Failure of Q906 on the Main Board.

- Check the number printed on the Main Board. If the number is 1-724-163-13 or higher, the countermeasure has already been applied.
- If the countermeasure has not yet been applied, replace **Q906** as indicated below. Note that the original Q906 is a chip transistor whereas the replacement is a lead type. Mount the replacement part to the lands of Q906 as shown below.

Former			New	
Ref.	Description	Part number	Description	Part number
Q906	2SC1623T1-L5L6	8-729-120-12	2SC2001TP-LK	8-729-142-46
