## T echnical T ip

FILE	TAOSC-TT-20050308-01
DATE	08 February 2005

<b>PRODUCT</b>	CTV & PJTV
<b>Part No:</b>	Scan Module MDFS03 ( 23148027 )

### Another countermeasure

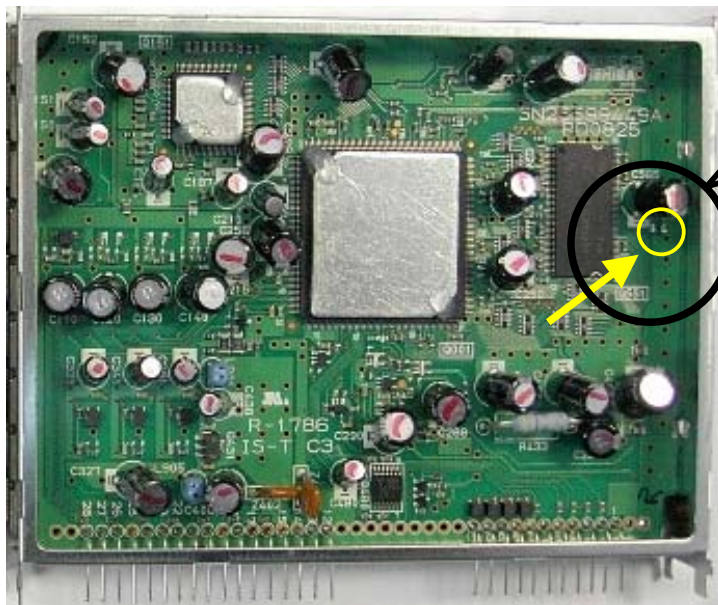
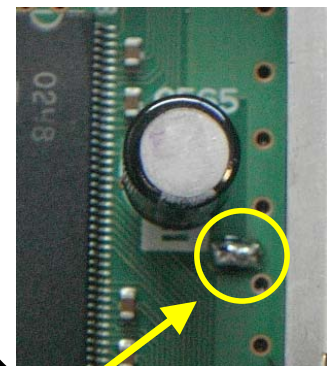
Symptom: Distortion or white peak noise appear on the screen

Cause : Poor ground at capacitor C565

Remedy: Solder the point refer to the attached Picture
