## T echnical T ip

FILE	TAOSC-TT-20050304-01
DATE	04 February 2005

<b>PRODUCT</b>	Scan Converter
<b>Part No:</b>	23148027

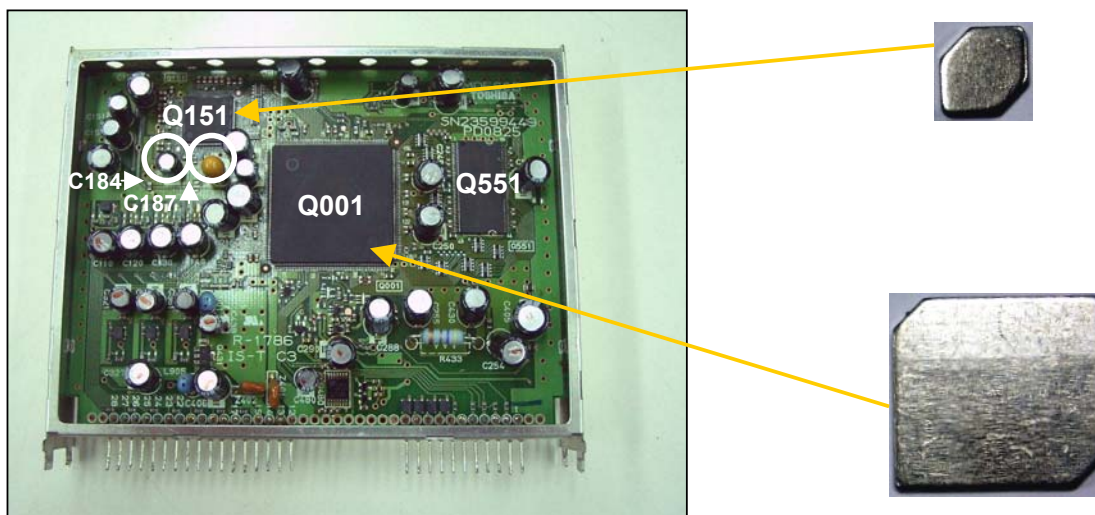
Location	Description	Part No
C184	22uF 16V (Electrolytic)	2479 4220
C187	22uF 16V (Electrolytic)	2470 4220

Repair the Scan converter board by:

- 1) Re-solder those IC Q001, Q151, Q551 and some other components if needed. (Use Lead Free Solder)
- 2) Add heat sink to IC Q001; Q151.
- 3) Replace C184, C187 as show in below photo

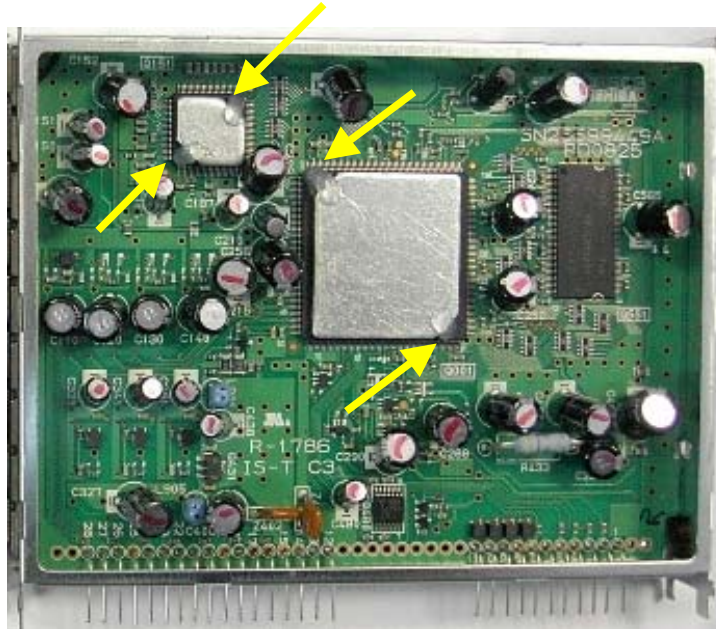
Add silicon to prevent drop off

Description	Part No:
Silicone ( TSE 3843-W- Adhesive )	23960136
