AFFECTED MODELS: All 25"AND UPPER MODELS WITH 11AK19PRO CHASSIS .

REASONS OF CHANGE:

DEFECT OF THE RGB AMPLIFIER TDA 6108 ( IC 901 )  
TO CATCH A BETTER RELIABILITY ACCORDING SPARKS OF THE PICTURE TUBE THE CRT-BOARD  
WAS CHANGED . THIS NEW CRT BOARD AS ALSO AVAILABLE AS SPARE-PART .

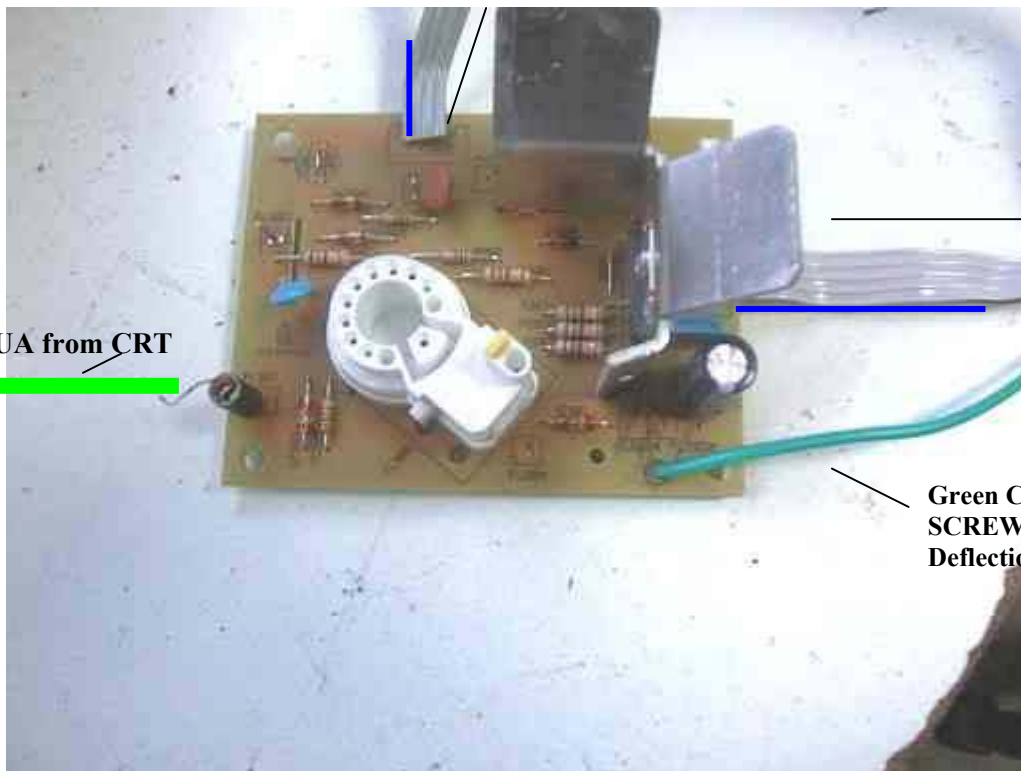
NEW CRT - BOARD

**NOTE 1: WHEN THE NEW CRT-BOARD IS USED AS SPARE-PART , THE  
AVAILABLE CURRENT CONNECTOR CABLE BETWEEN CHASSIS AND CRT  
BOARD CAN BE USED .  
PAY ATTENTION FOR CONNECTING CABLE PL902 AND PL901 IN THE  
RIGHT POSITION ( SEE PHOTO )**

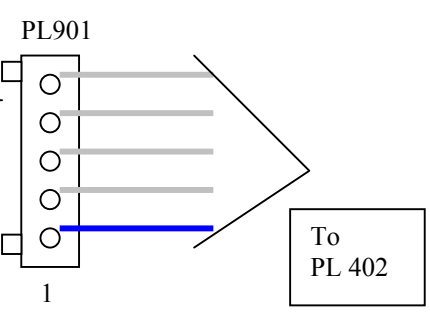
AQUA from CRT

Green CABLE must be fix to SCREW of HOLDER of Deflection coil
