Service Bulletin

All models with AK36
Chassis.

**Service
Bulletin No: 125**

SUBJECT : Q 602 defect

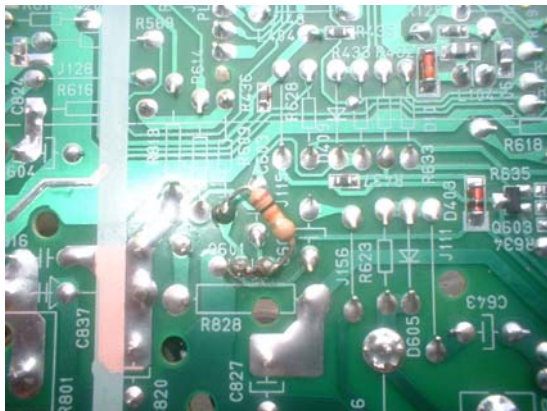
TV does not work due to Q602 broke down

Hor. Transistor Driving Condition during switching ON/OFF.

After changing the defected Q602,

In order to improve Q602 resistant to sparks, modify the chassis as given below.

Solder RES CF 1/4W 10K J BETWEEN BASE AND COLLECTOR OF Q601 (Hor.driver Transistor) as shown in below.
