CIRCUIT DIAGRAM FOR MC-006A CHASSIS MAIN2 & SUB ASSY

P/N : 3854VA0075A-S1(2/2)

Date : 2001.09.14

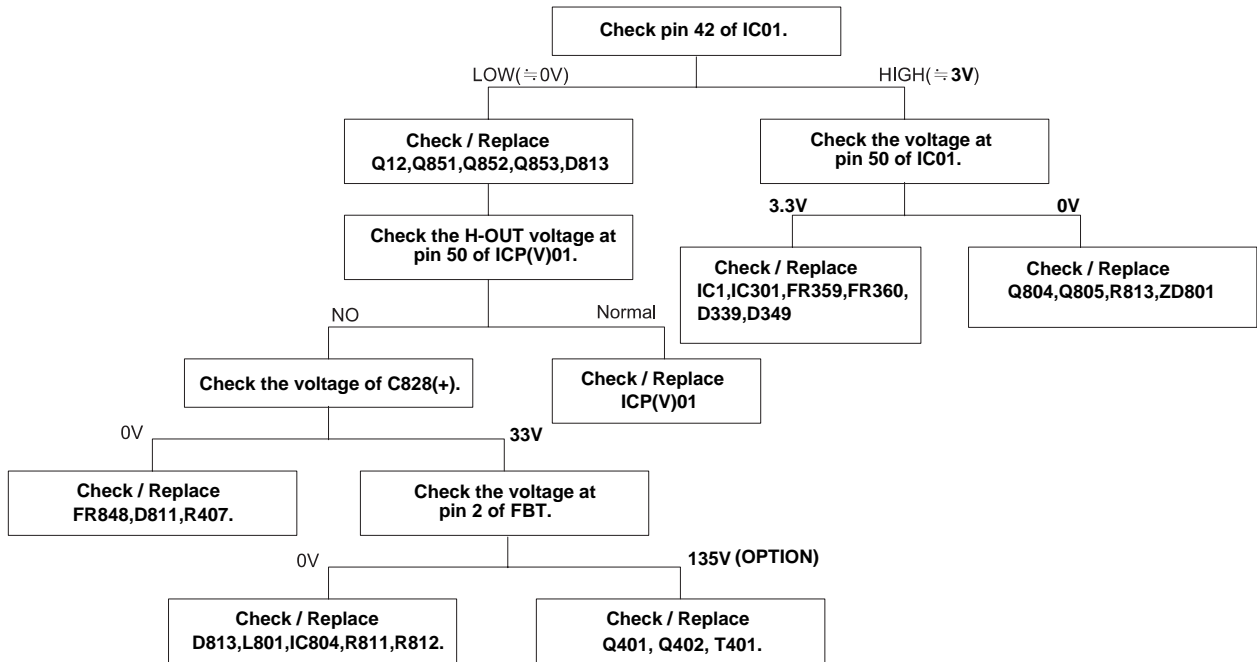
NO POWER ON BUT SMPS WORKING

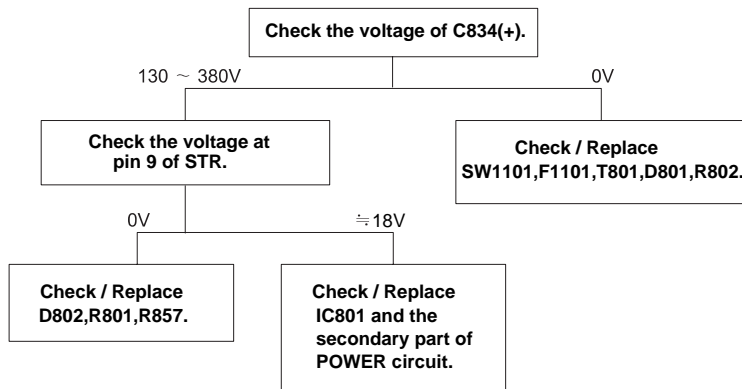
NO POWER (NOT WORKING SMPS)

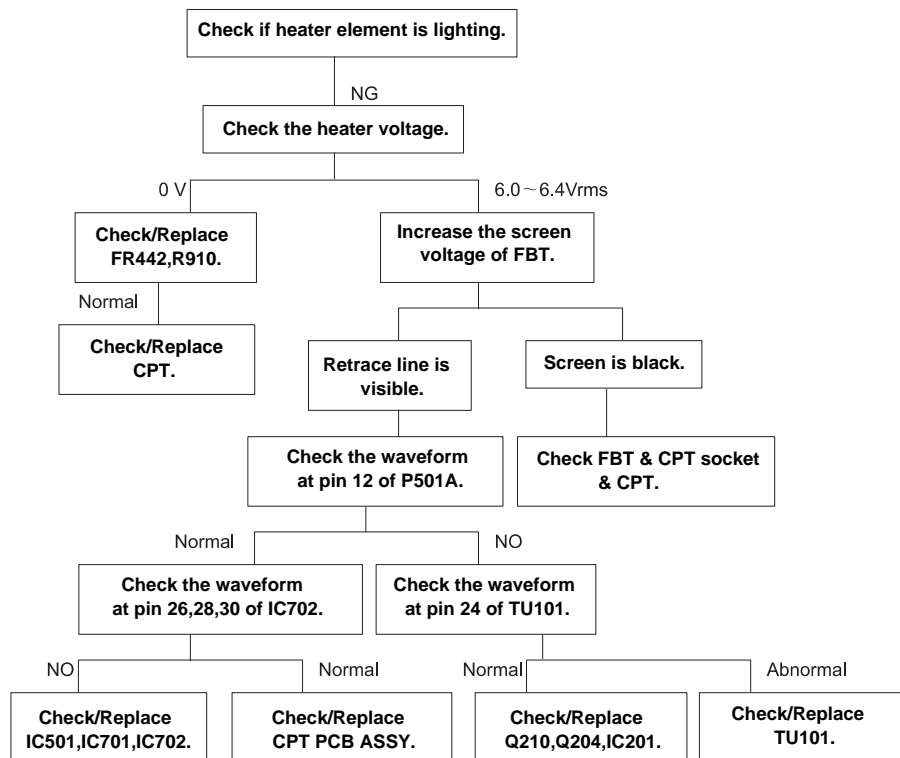
NO RASTER & PICTURE (H-OUT OK)

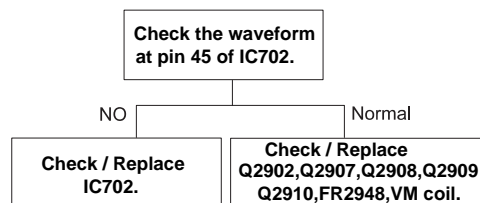
VM DON'T WORKING

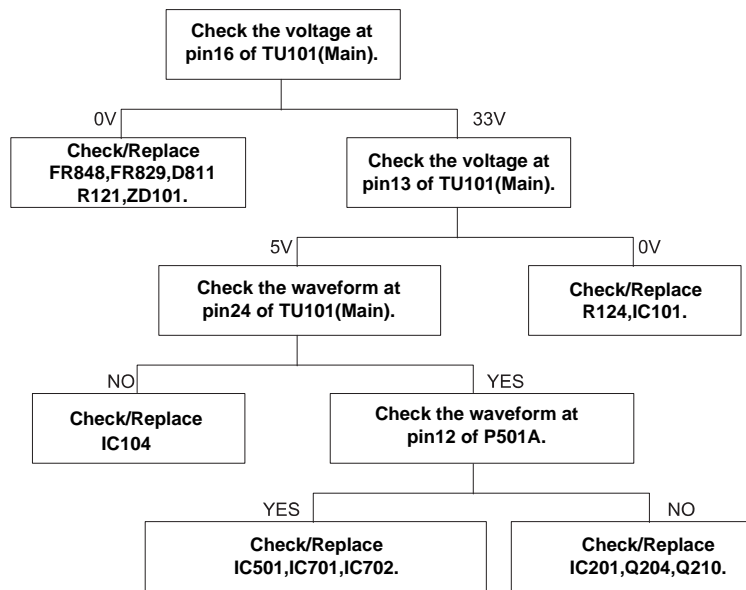
DON'T CATCH CHANNEL(MAIN)

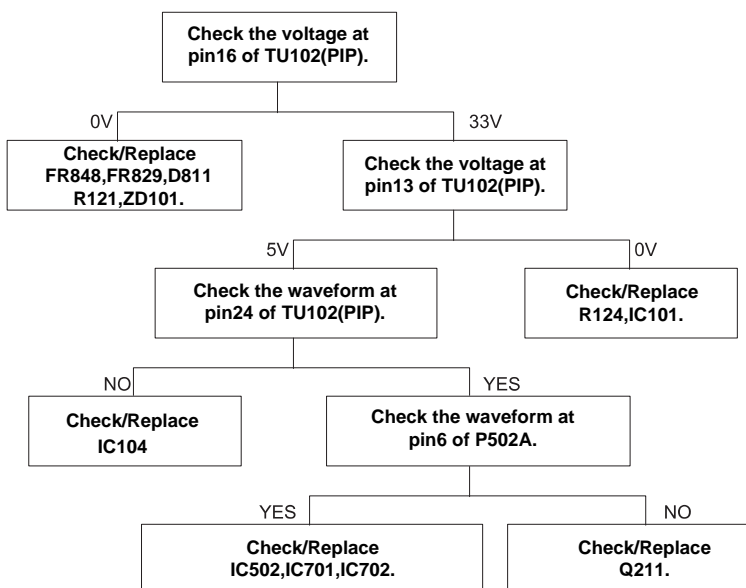
NO PIP / NO DOUBLE WINDOW

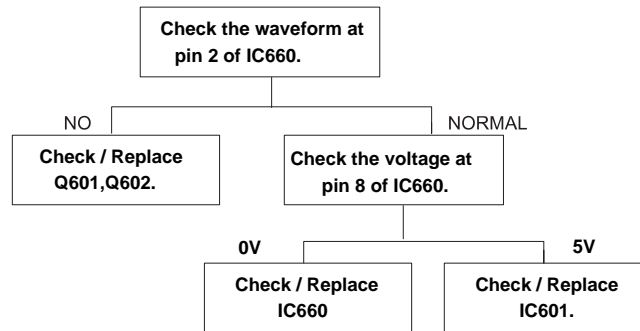
NO CENTER SPEAKER SOUND (BUT MAIN SOUND OK)

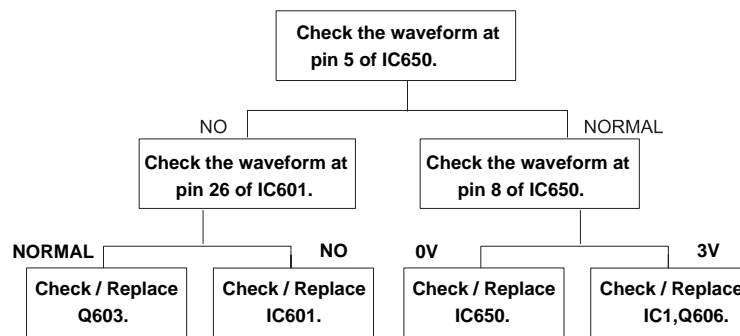
NO WOOFER SPEAKER SOUND (BUT MAIN SOUND OK)

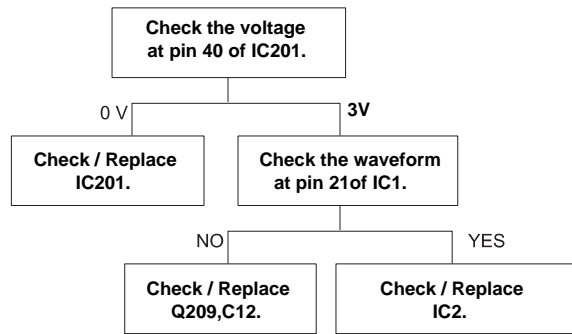
NO TELETEXT

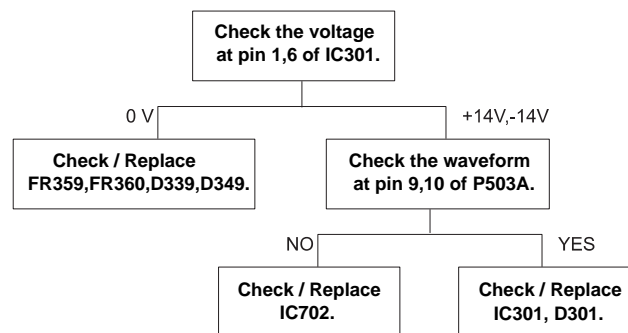
NO VERTICAL DEFLECTION

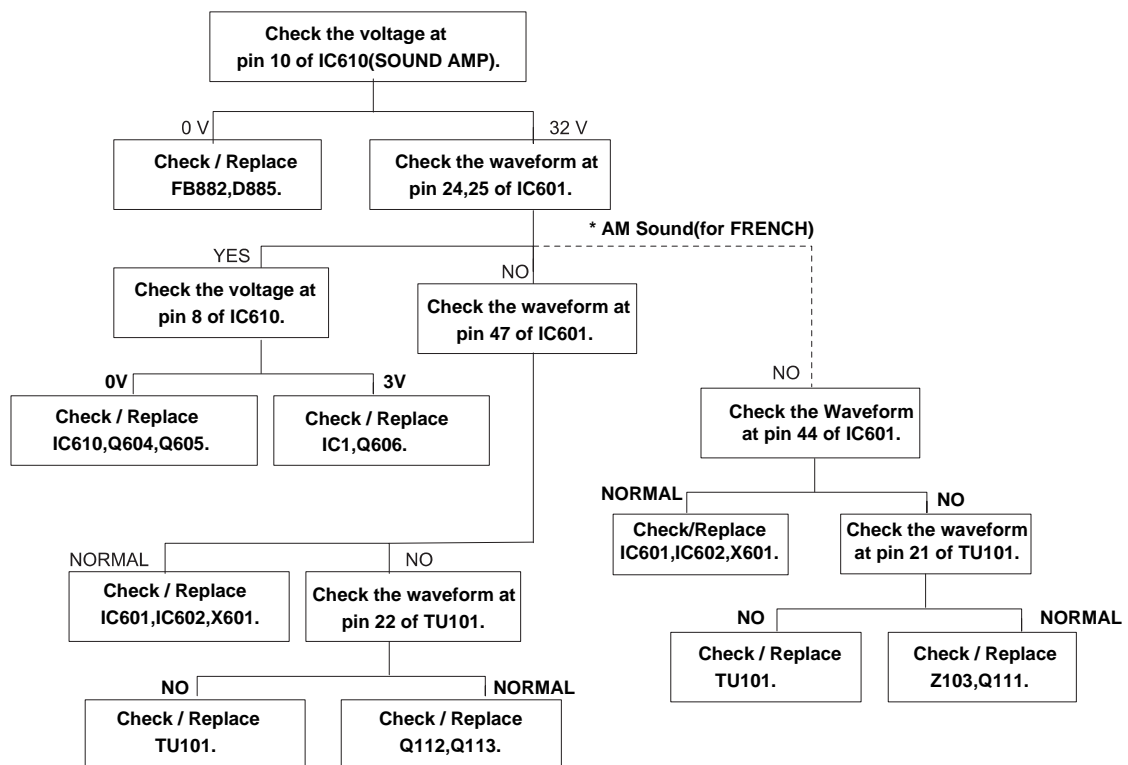
NO FRONT L,R SPEAKER SOUND(PICTURE OK)

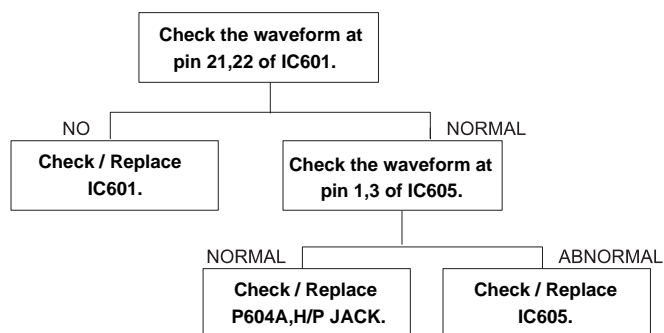
NO SOUND FROM H/P jack(OPTION) (but Main Sound OK)
